# Case Study Baptist General Convention of Oklahoma

3800 North May Avenue Oklahoma City, OK

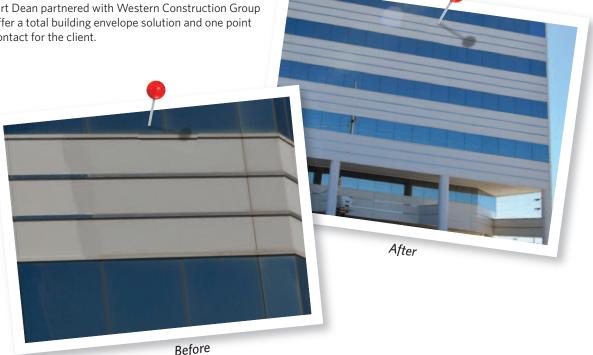
The building's factory-applied coating system reached the end of its service life, leaving the façade discolored and damaged.

Additionally, building sealant and gaskets reached the end of their service life and began to fail.

Stuart Dean refinished more than 35,000 square feet of the exposed architectural metal on the building's façade, including the application of protective coatings on these surfaces and the removal of sealants and gaskets. Stuart Dean also cleaned and re-polished all stainless steel window mullions on all elevations and added new stainless steel column base covers at the ground floor entrances.
